**25th Congress of
International Federation for
Heat Treatment and Surface Engineering**

11-14 September 2018 | Xi'an China

PROCEEDINGS

Failure Analysis

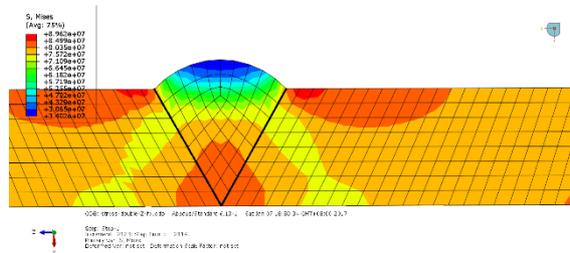
Fig.1 local residual stress field distribution in weld

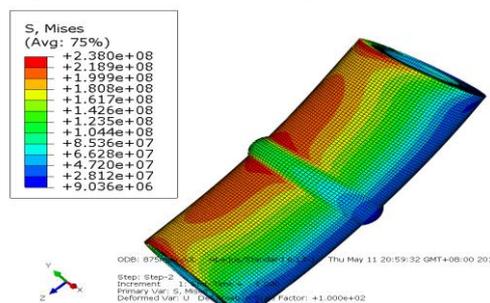
The results shows that the welding residual stress is greater than greater than allowable stress of T23 tube under working temperature, therefore, the effect of T23 heat treatment after welding to reduce the crack of T23 waterwall crack is obvious; The working medium load plays a great role in the hoop stress of the waterwall tubes, and promotes the cracks in the butt welds ;The axial stress on the waterwall tubes produced by the installation defect stress is also obvious, the stagger joint, and other installation defects are the main reason of crack propagation of spiral coil waterwall.

Fig.3 Stress distribution after superposition of the working medium load and welding residual stress as well as bending moment

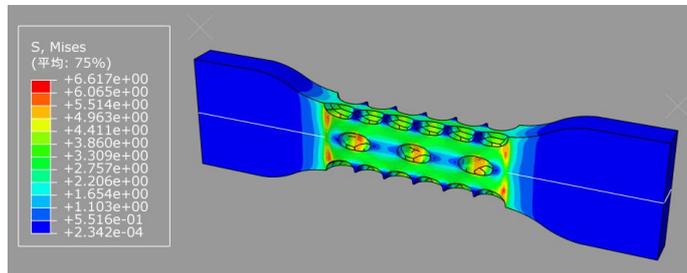
Fig.4 showed the stress distribution diagram of RPUFs simulated by CSM. It can be seen that the internal stress concentrated on the cellular structure which was perpendicular to the direction of tensile stress. However, the cellular structure region where the stress concentrated decomposed during heat treatment according to the results of TGA. It made the decomposed cellular structure break down more easily and finally accelerated the failure of RPUFs.

Fig.4 Stress distribution diagram of RPUFs simulated by CSM

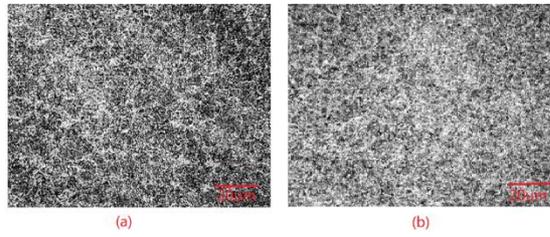
In order to identify the causes, diverse characterizations were carried out. Chemical compositions and metallurgical structures of bearing's matrix materials were inspected by photoelectric direct reading spectrometer and metallographic microscope. The results were exhibited the Table 1 and Fig.2, respectively. It was obvious that the carbon content of outer ring, proportional to the steel hardness, was below standard. The chromium exceeded the requirement, while higher chromium could bring about more retained austenite, which were apt to deform under stresses in the microstructure after heat treatment. Thus, it could be concluded that hardness of the outer ring of the failed bearing is intrinsically unqualified. The conclusion also could be supported by the metallographic structures Fig.2a. It was can be seen that more grain boundaries of the retained austenite were present in the outer ring.

Fig.2 Metallographic structures of the failed roller bearing: (a) outer ring, ×500, (b) roller, ×500

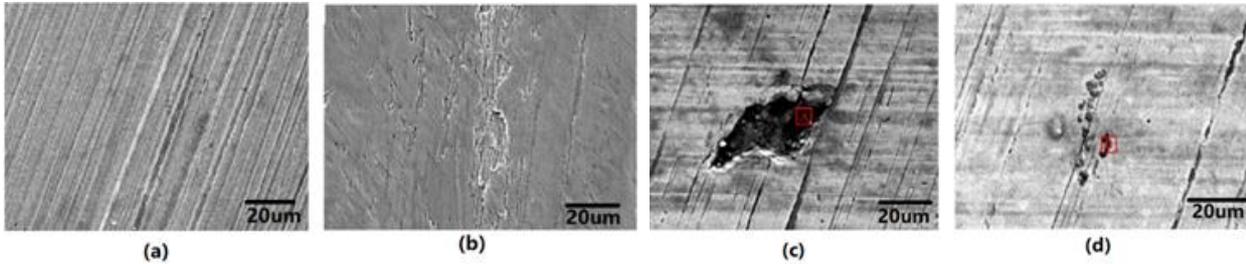
Scanning electron microscope was used to detect the microscopic morphologies on the fracture surfaces and contact surfaces. As shown in Fig.3. Typical morphology of quasi-dissociation fracture of dissociation steps along with dimples were presented. Traces of mutual friction and squeeze could be also found on the fracture surface, in Fig.3b, c, respectively, which may have resulted from the contact between the two counterfaces of the outer ring after fracture. Meanwhile, actinomorphous fringes had originated from the corner of the fracture surface. This indicated actually the distinct evidence of the fracture origin.

Based on these analytic results, conclusions were put forward that the outer ring of the failed bearing was intrinsically unqualified, and surface of the outer ring of the bearing contained contact fatigue damage. The lubricating grease was subjected to severe thermally induced degradation due to high service temperature, and the lubricant film in the roller/outer ring contacts was not formed effectively. Thus, the interaction between dry friction and impact both led by the degraded grease due to decomposition and oxidation, which resulted in serious wear of the outer ring, was the main cause that originated and propagated the fatigue cracks on the corners of the outer ring, and eventually resulted in the fracture failure of cylindrical roller bearing.

Fig.3 SEM morphologies of the contact surface on the outer ring: (a) normal morphology, (b) irregular trenches, (c) concave, (d) adhered substances

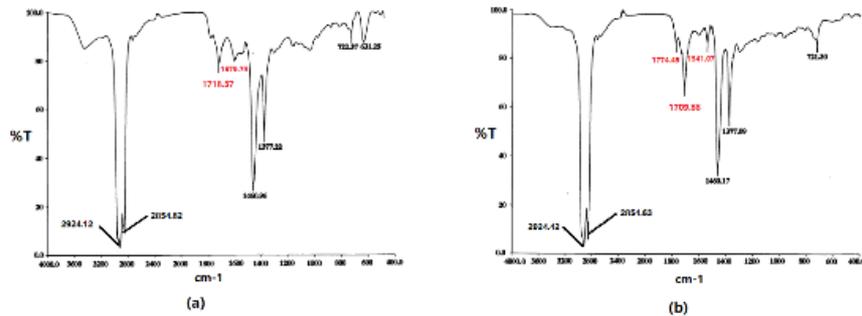
What's more, the Fourier transform infrared spectroscopy (FTIR) and X-ray diffraction (XRD) were utilized to characterize degradation extent of the greases applied within the roller bearing. The FTIR of fresh and used grease were exhibited in Fig.4. Comparing the results of both, intense carbonyl (C=O) band at 1709 cm^{-1} , that was directly proportional to the degradation degree of grease, occurred in the infrared spectrum of the used grease, indicating oxidative degradation of used greases. The results on XRD of fresh and used grease (Fig.5) revealed that the used grease sample was a complex mixture of compounds like MoS_2 , Cu-Zn intermetallic and FeCr_2O_4 , rather than only MoS_2 in fresh grease, which further verify the oxidative degradation of used greases.

Fig.4 FT-IR spectra of (a) fresh and (b) used grease sample

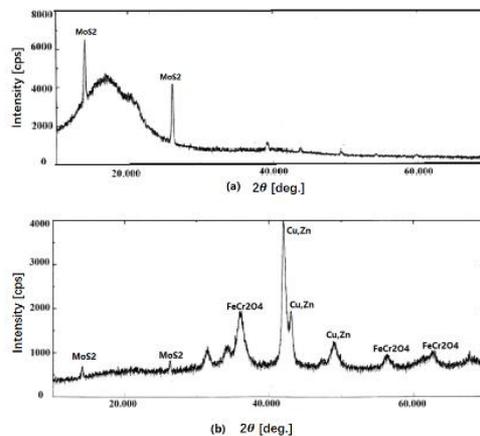
Fig.5 XRD spectra of (a) fresh and (b) used grease sample

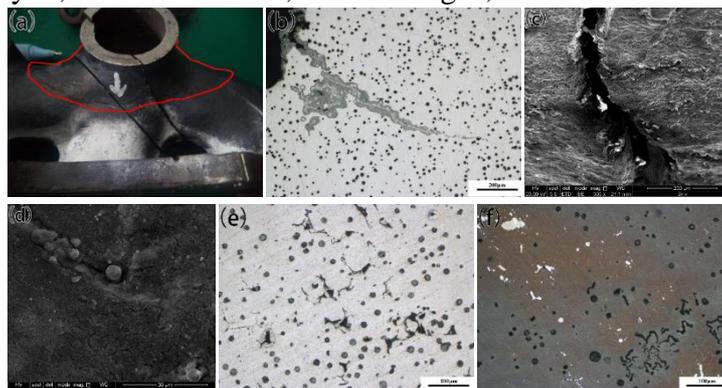
According to the above tests, it could be concluded that the cracks were caused by thermal fatigue, which was related to two factors. On the one part, due to the high temperature gas erosion and the temperature difference, a high temperature stress field around the flange plate was generated. It would lead to high stress around the flange plate. On the other part, the cast defects in the cast exhaust manifold would cause stress concentration. Under the effect of these two factors, the cracks occurred around the flange plate.

Based on the above analysis, some practical countermeasures were proposed to solve corresponding problems. Remove the tempering process to reduce the precipitation of carbides. 1) Raise the pouring temperature to improve the refining process. 2) Increase the cooling rate after normalizing process to avoid the precipitation of the phase with low melting point. 3) Cut down the nickel content to reduce the elemental segregation. 4) Add heat sink to the flange plate to reduce the thermal stress.

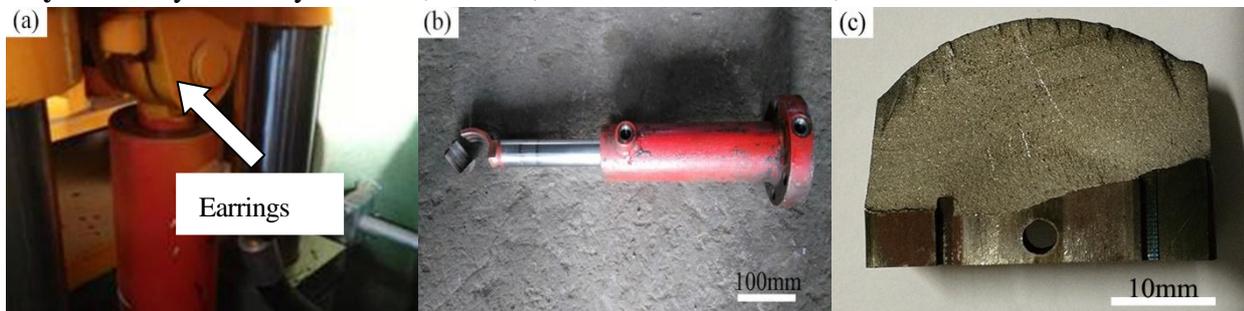
Abstract: Hydraulic brick making machine is a machine that producing high-strength cement brick, hollow block or Color brick road brick through scientific ratio, water mixing and hydraulic press, using bira nest, cinder, fly ash, stone powder, sand, gravel, cement as raw materials. As a new alternative clay brick equipment, hydraulic brick machine that can produce a variety of models of new wall products through the replacement of the mold has functions of environmental protection, energy saving, hydraulic, electronic control, mechanotronics. 45 steel is high-quality carbon structural steel, whose hardness is not high. It can be cut easily and shows a good comprehensive mechanical properties after quenched and tempered. Thus it is widely used in various types of important structural parts, especially those connecting rods, hooks, bolts, gears and shafts working under alternating load. The hydraulic cylinder is the main force and power support element of the construction machinery, and the movement of the mechanism is achieved by the extension and retraction of the hydraulic cylinder piston rod. The force parts of a hydraulic cylinder often fail because of the host vibration or oscillation. Meanwhile, the hydraulic cylinder is subjected to a great deal of internal pressure up to 40 MPa or even much higher. Higher demands are required for the structure of the hydraulic cylinder to adapt to the complex force conditions, especially the hydraulic cylinder earrings, which have a higher safety requirements as the main force parts and movement support parts. The working position of hydraulic cylinder earrings in the hydraulic brick machine is given in Fig.1(a). The macroscopic morphology of the broken hydraulic cylinder earrings are shown in Fig.1(b). The morphology of sample cut from the fracture of the earring with a special cutting machine and cleaned with an SB-5200D ultrasonic cleaner was shown in Fig.1(c). This paper investigates the failure of an ear on a hydraulic cylinder. The hydraulic cylinder ear on a hydraulic brick making machine produced by a factory was soon cracked during running. The fracture morphology, chemical composition, microstructure and hardness of 45 steel failure ear were analyzed by using of scanning electron microscopy, energy spectrometer, direct reading spectrometer, optical microscope and microhardness tester. The results showed that more Al_2O_3 and sulfide non-metallic inclusions in the fracture section, the defects microstructure were net ferrite and pearlite, the inside were exist obvious band microstructure and widmanstatten structure, the local coarse grain were the main reason cause the failure of hydraulic cylinder ear.

Fig.1 Macromorphologies of the fracturing hydraulic cylinder ear: (a)working position of ear; (b)fracture of ear; (c)morphology of fracture

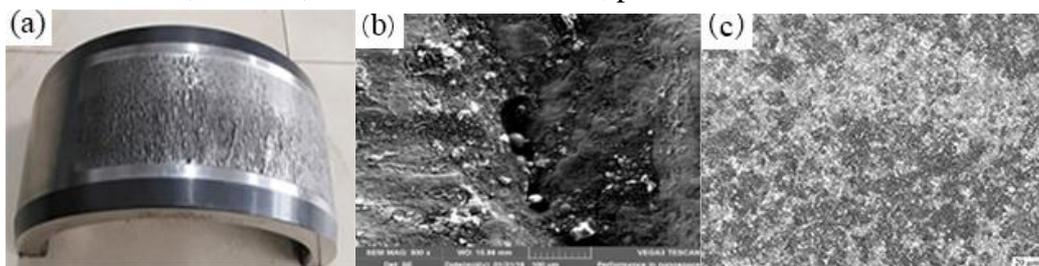
A large rolling bearing in the factory experienced serious wear of the inner ring of the bearing during use, as shown in Fig.1(a). The chemical composition inspection, fracture microscopic examination, non-metallic inclusions test, hardness testing and metallographic examination of GCr15SiMn steel were carried out by direct reading spectrometer, scanning electron microscope (SEM), energy spectrometer, Rockwell hardness tester, optical microscope and stereo microscope. The results show that there are more inclusions of iron containing metal oxides in the wear zone, as shown in Fig.1(b), and the microstructure of the wear zone is granular carbides, hidden-needle tempered martensite and black troostite, as shown in Fig.1(c). The presence of black troostite in the inner ring of the worn bearing is due to the slow cooling process of quenching, precipitation of black troostite along the original austenite and still existing organization after low temperature tempering, whereas the presence of black troostite will reduce the hardness of inner ring of worn bearing, the low hardness of the inner ring of the worn bearing can lead to plastic deformation at the wear zone, as well as indentation, cracks and holes are caused by plastic deformation, the concentrating effect of these factors led to the failure of GCr15SiMn steel large rolling bearing.

Fig.1 worn bearing inner ring: (a) macro-morphologies of the worn bearing inner ring; (b) micro topography of the worn bearing inner ring; (c) microstructure of the worn bearing inner ring
